**ALBERTA BUILDING ENVELOPE
FAILURE ANALYSIS**

MUNICIPAL AFFAIRS
Innovative Housing Grants Program

June 1991

G. F. Johnson
Morrison Hershfield Limited

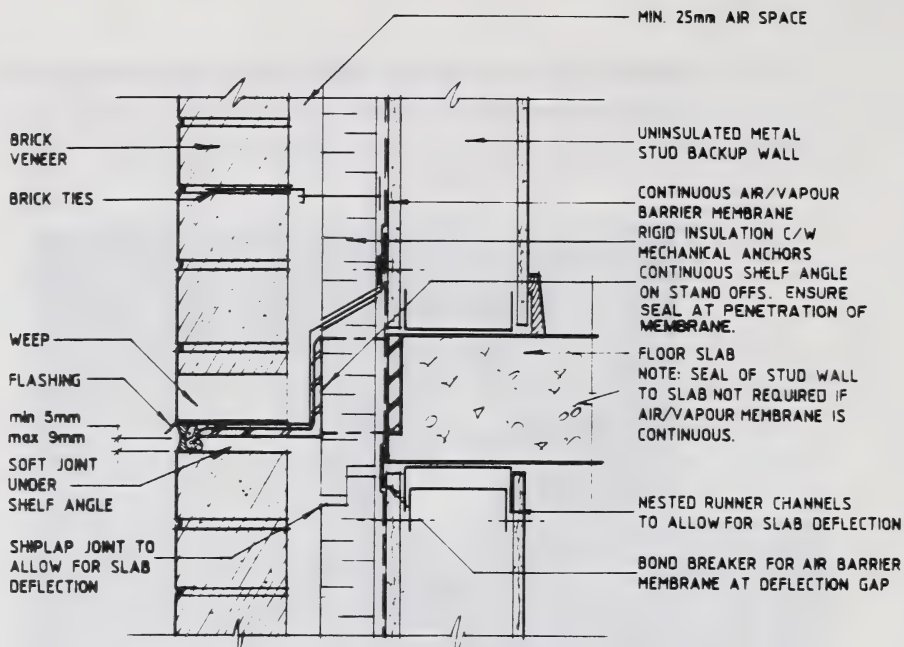
Suggested Masonry Veneer Detail
Figure 9

found. Figure 9 illustrates a suggested masonry shelf angle detail, including measures necessary to allow for creep and deflections. (See 4.4.12, Cost of Repair, for a discussion of these figures.)

For the purposes of cost comparisons, we chose the problems relating to masonry veneer shelf angles (see Figure 9, page 40). Buildings numbered 5, 24 and 38 all suffered shelf angle problems but as can be seen in Table 1 the costs are considerably different. For building 5, the problem is a lack of soft joints below the angle and can be resolved simply by cutting the mortar out from the joint below and applying a sealant. The cost for this portion of the repair is approximately \$300.00 per suite. For building 24, the problem is further complicated by the fact the flashings and weeps above the shelf angle were incorrectly installed and the weeps plugged with mortar droppings. The repair

(Refer to the C.M.H.C. publication *Seminar on Brick Veneer Wall Systems*, Drysdale, Keller et al).

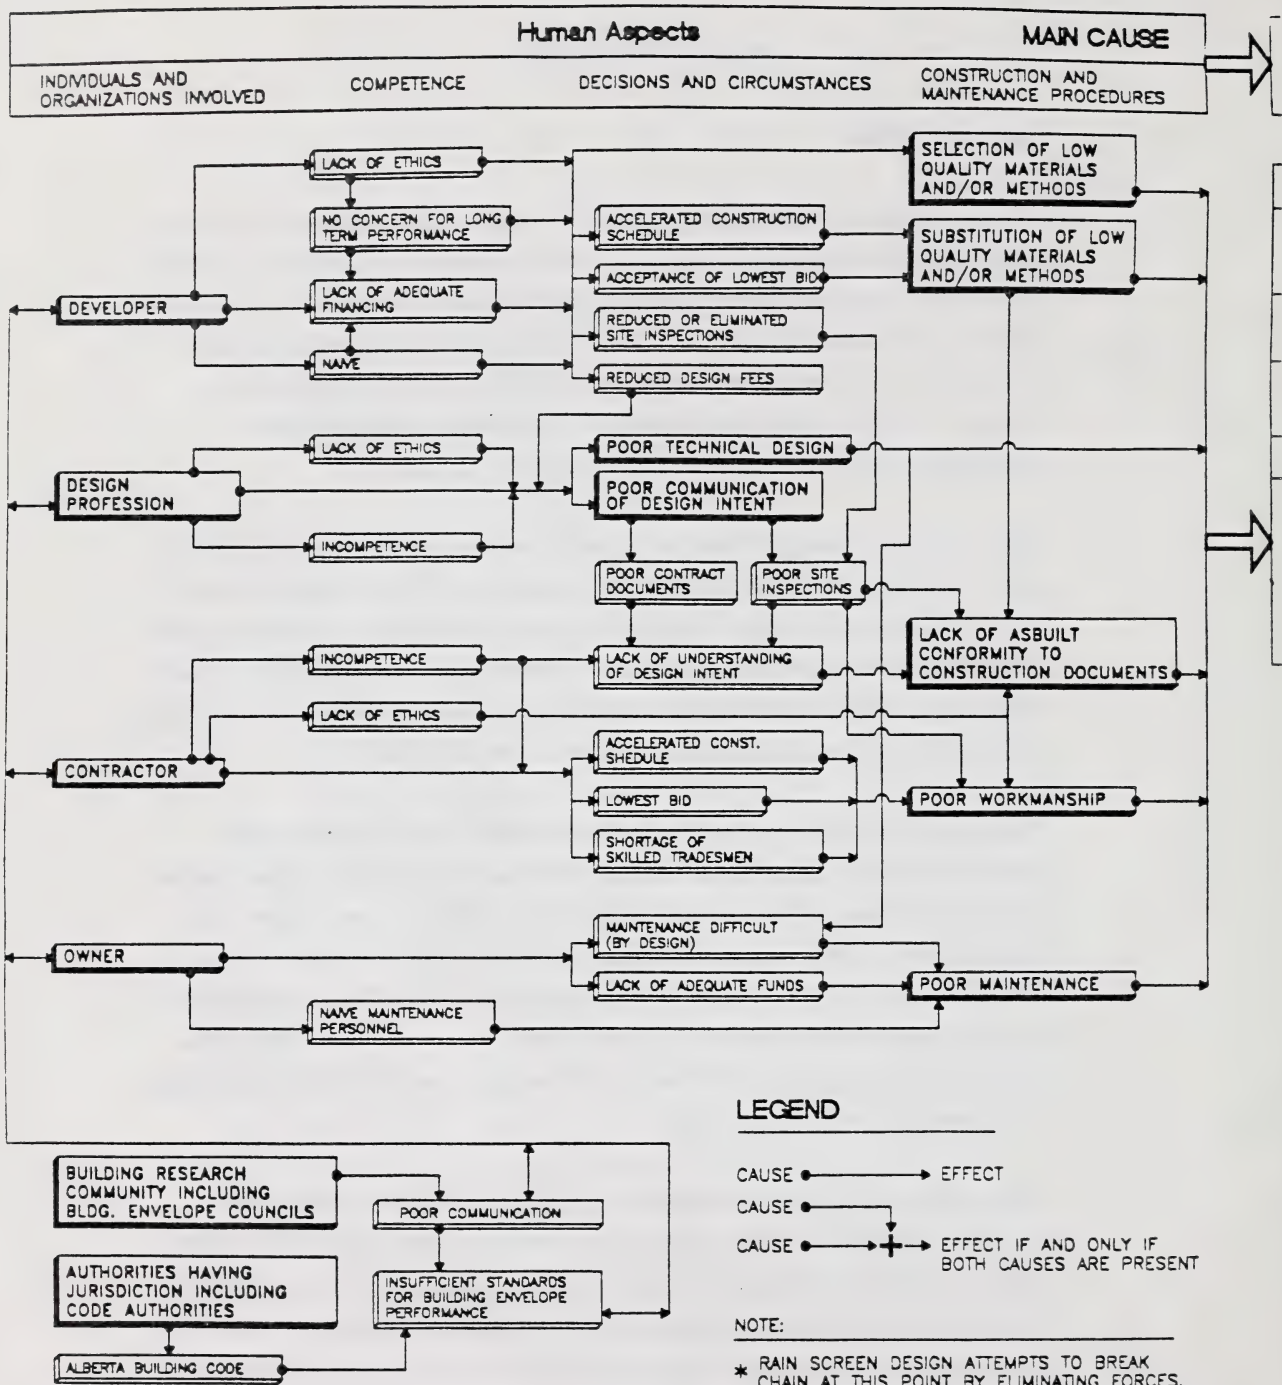
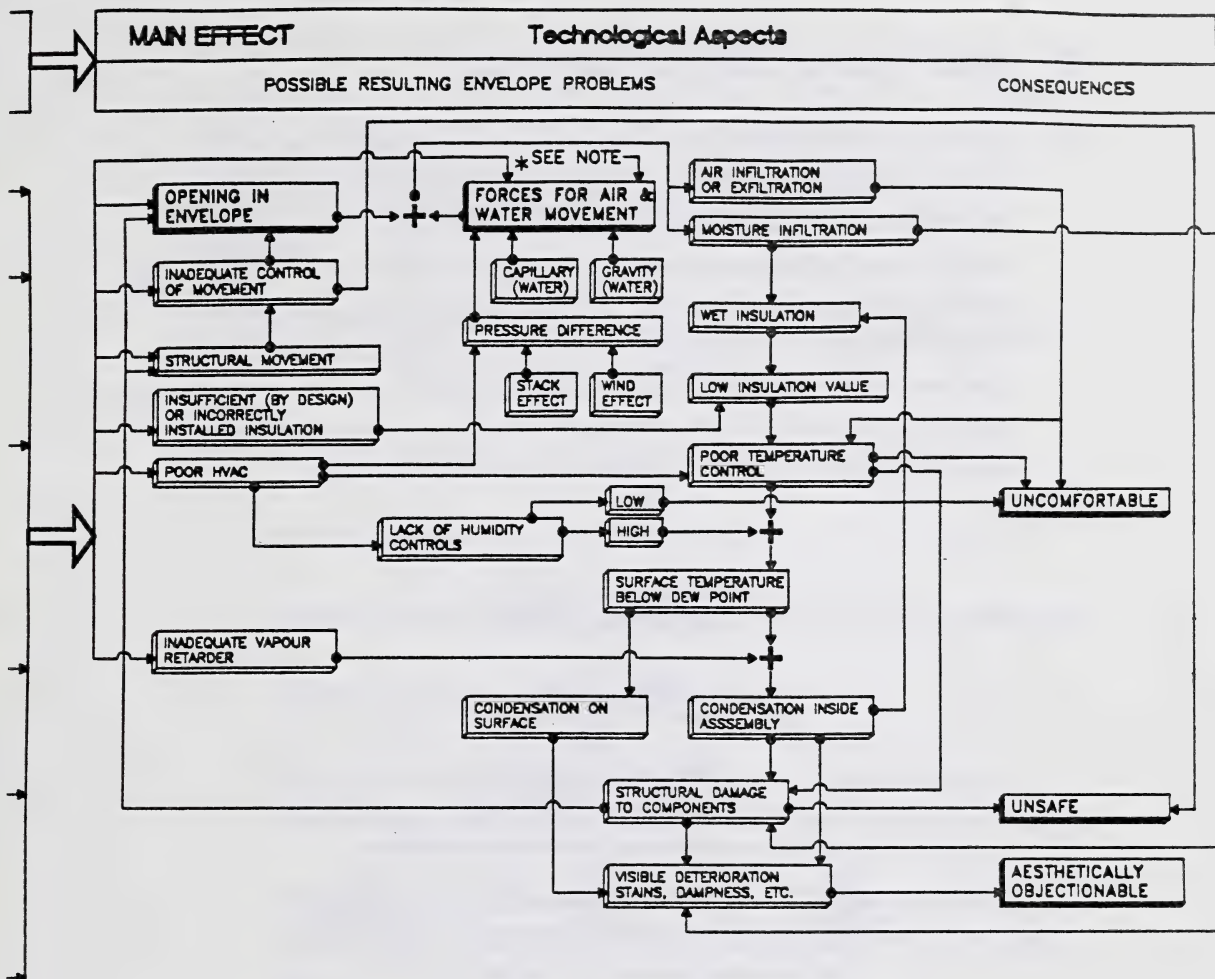
Figure 13

As discussed earlier, the building envelope must provide a comfortable, safe, and aesthetically acceptable environment for the occupants of the building. In order to accomplish this, the primary function of the envelope is to control air, moisture and heat movement through the assembly. When there is a failure in any one of these areas, a very complicated cause and effect interaction is almost always initiated. This cause and effect interaction is simplified and represented graphically in the Cause and Effect Chart, Figure 13, page 57.

The nodes of the chart are connected with one way arrows. The bullet end signifies the cause and the arrow head signifies the effect. Any one node may be the cause of several effects and may in turn be the effect of several causes. A large plus sign indicates the effect can result if and only if both causal events occur in unison. It is important to note that the rain screen principle is intended to break the chain of cause and effect at one of these locations notated with a plus sign. By removing many of the forces contributing to water infiltration, openings in the cladding cause few problems.

It is possible to start at any one node and trace the lines back to determine possible causes and, conversely, trace them forward to determine possible effects. In many instances the routes are very circular indicating a feed-back mechanism (ie: moisture infiltration may cause structural damage to components, which in turn may cause an opening in the envelope which may lead to more moisture infiltration).
